metro

3. General situation before encapsulation of the rusted metal parts observed in December 2014

4. General comment after observations during inspection in November 2015

5. Control of the Dry Film Thickness (DFT)

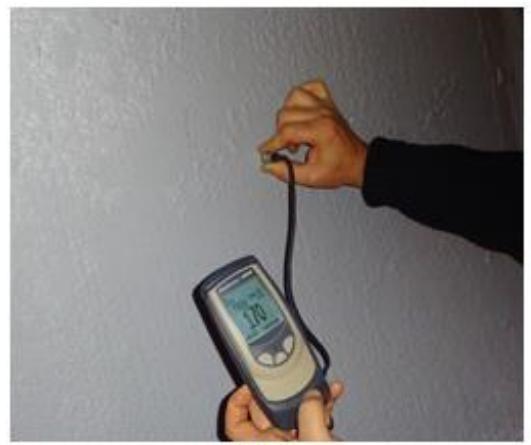
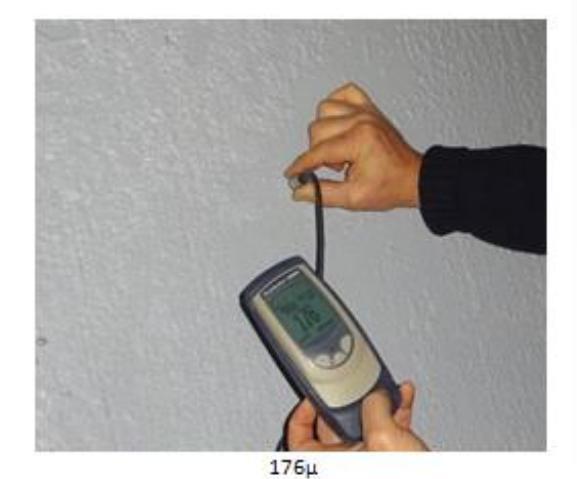
170 µ

Below some DFT measurements, taken on the most flat possible areas after calibration by use of plastic shim (calibrated at 255 micron), are shown.

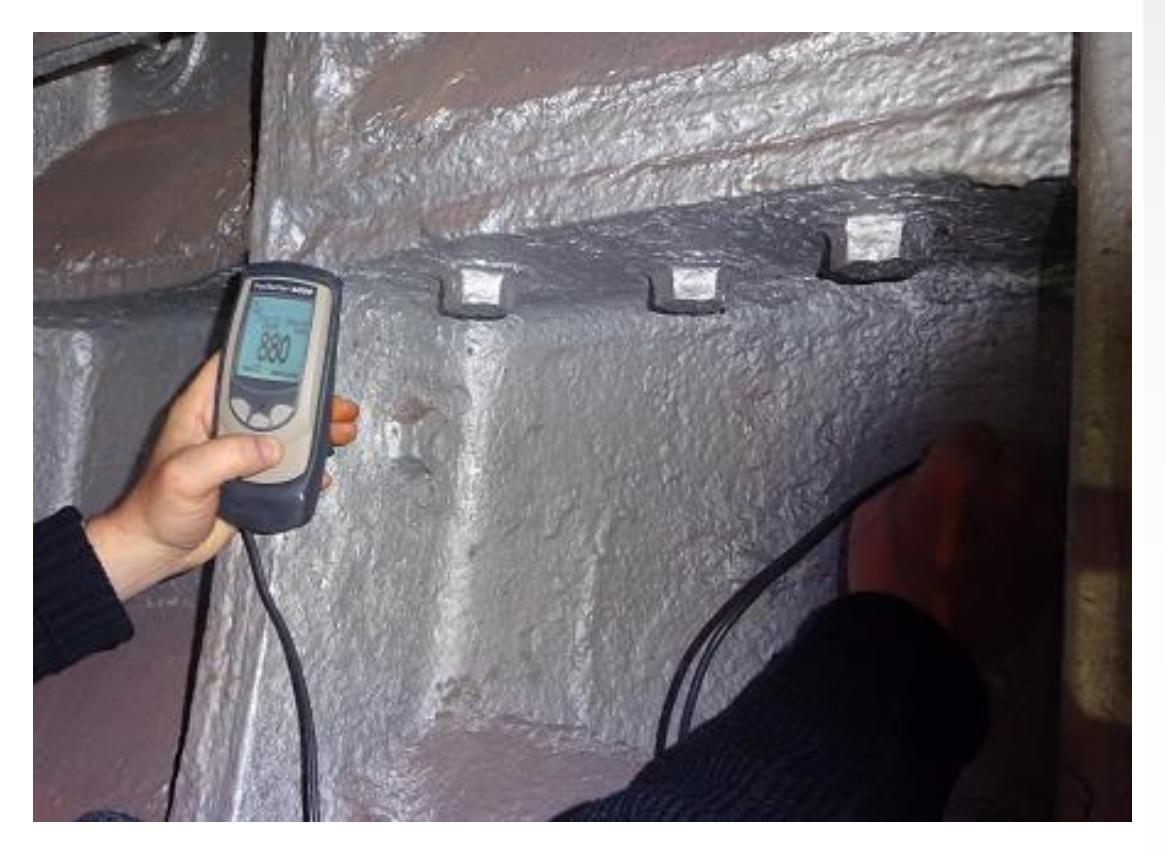
880 µ

It must be noted that, due to the very rough surface profile, in most areas it was impossible to find a smooth surface to make appropriate measurement by using a Delfesko PosiTector 6000 with Type 2 gauge.

This translates into much higher thickness measurements, as shown below.

I can confirm that, during my visit, I have not seen 1 single check point having less than 150μ DFT and never spotted an area showing corroded pin holes.

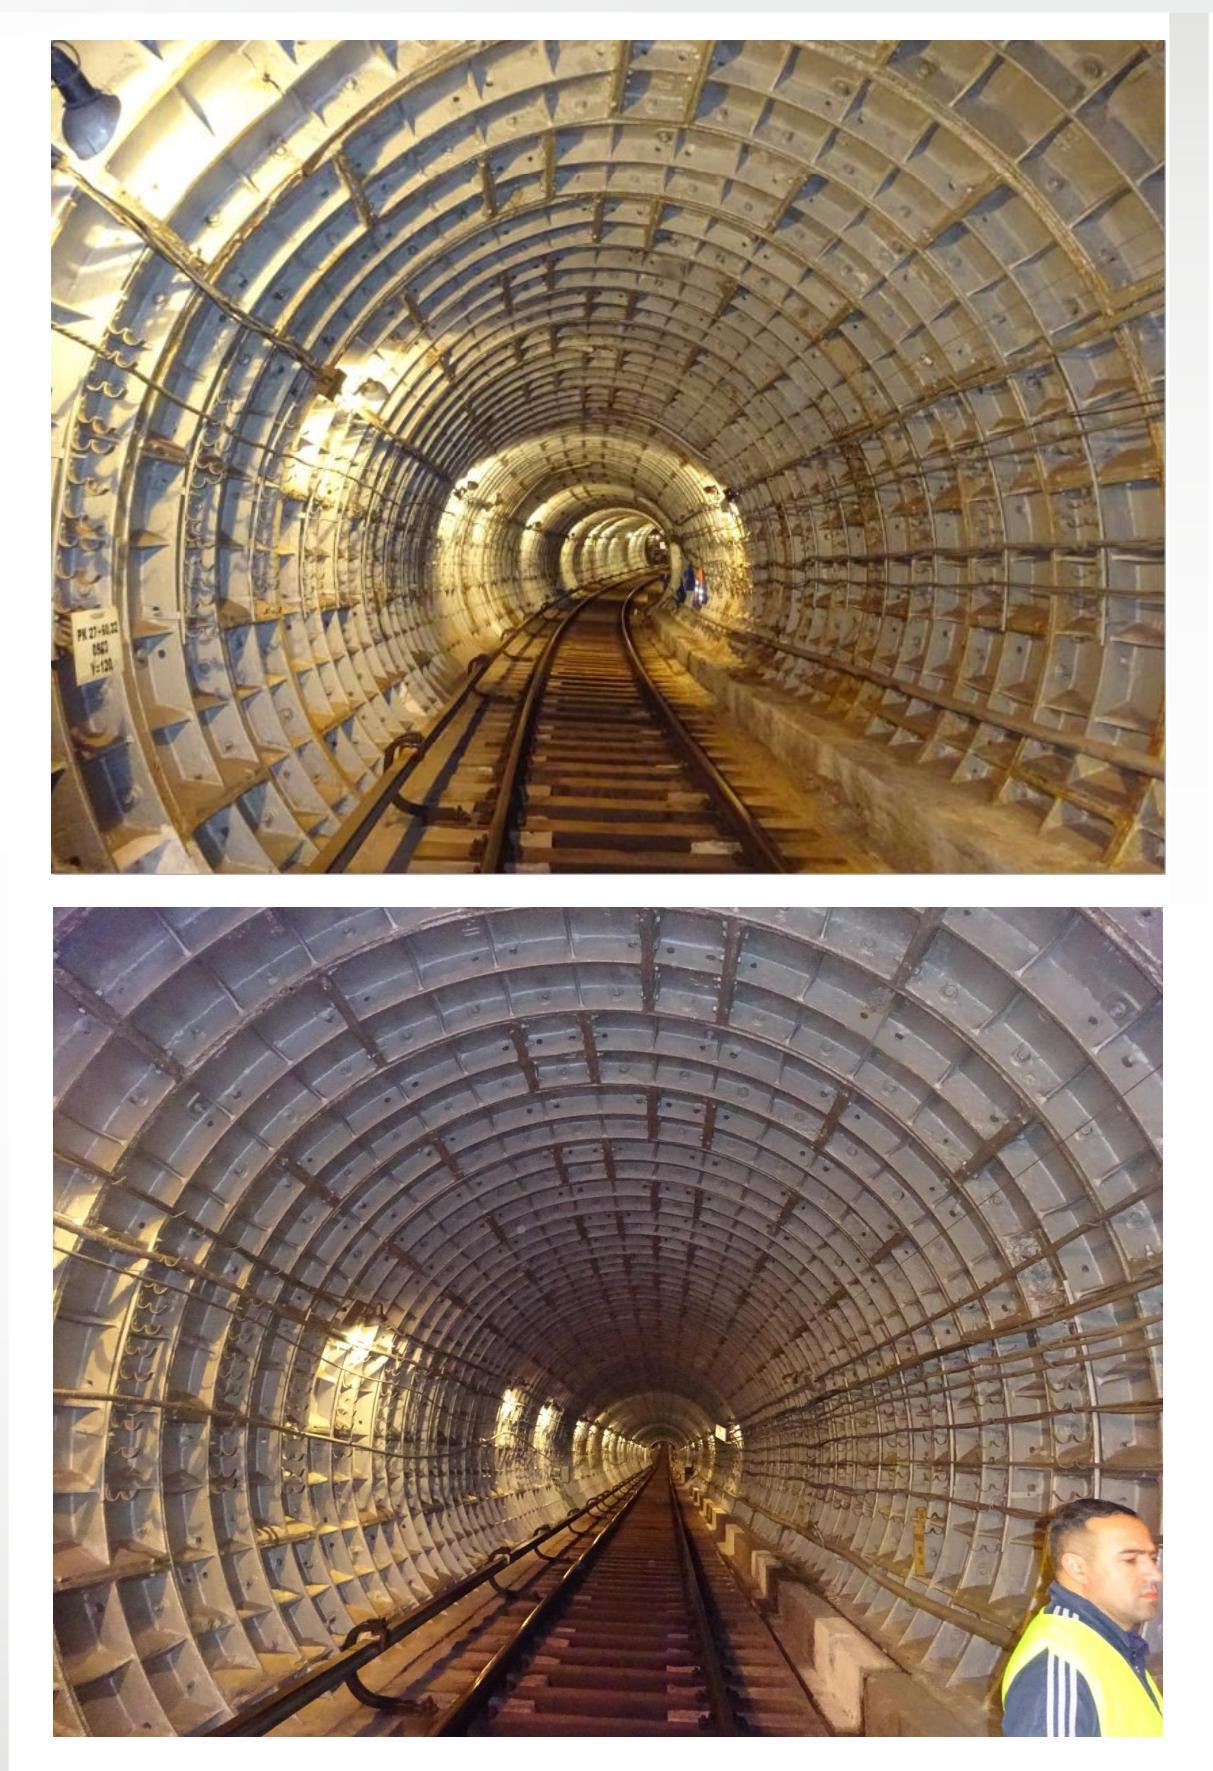
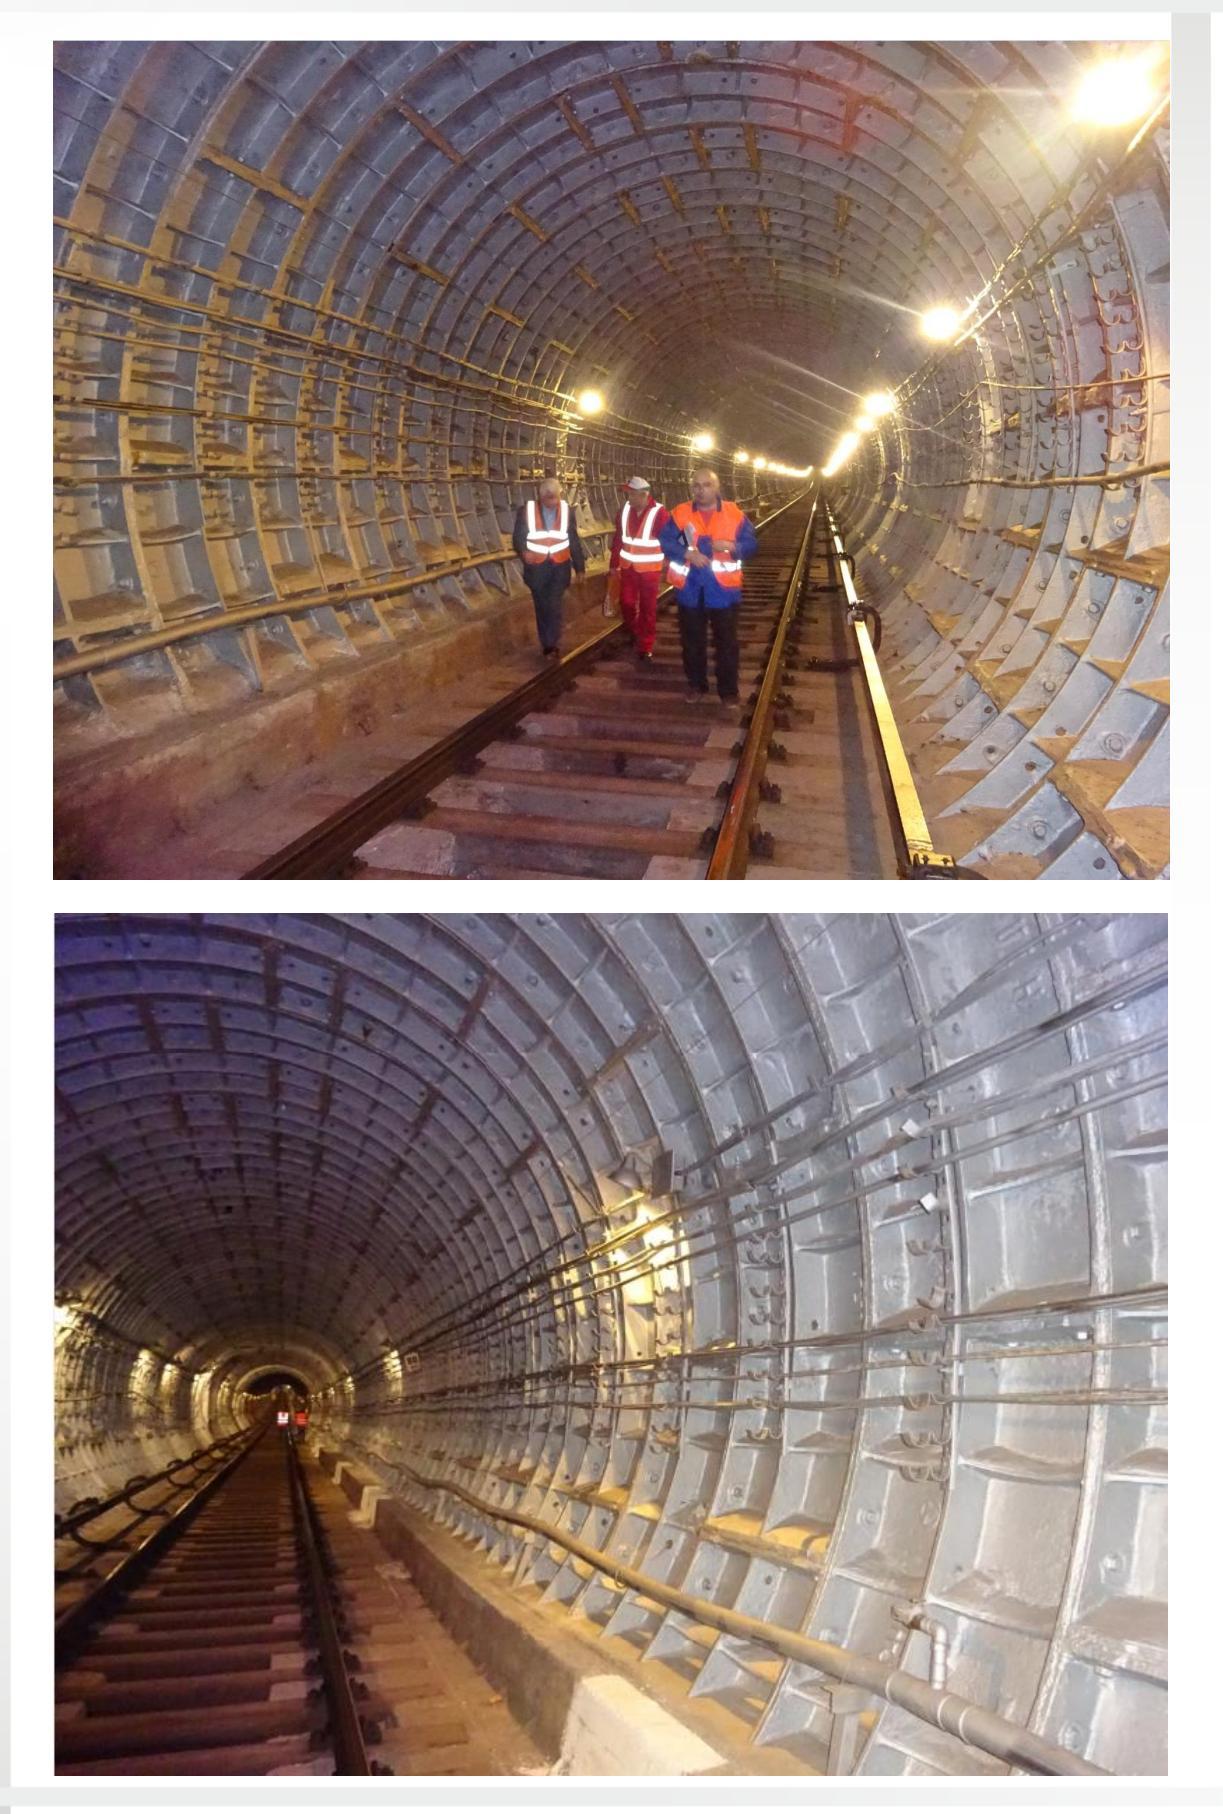
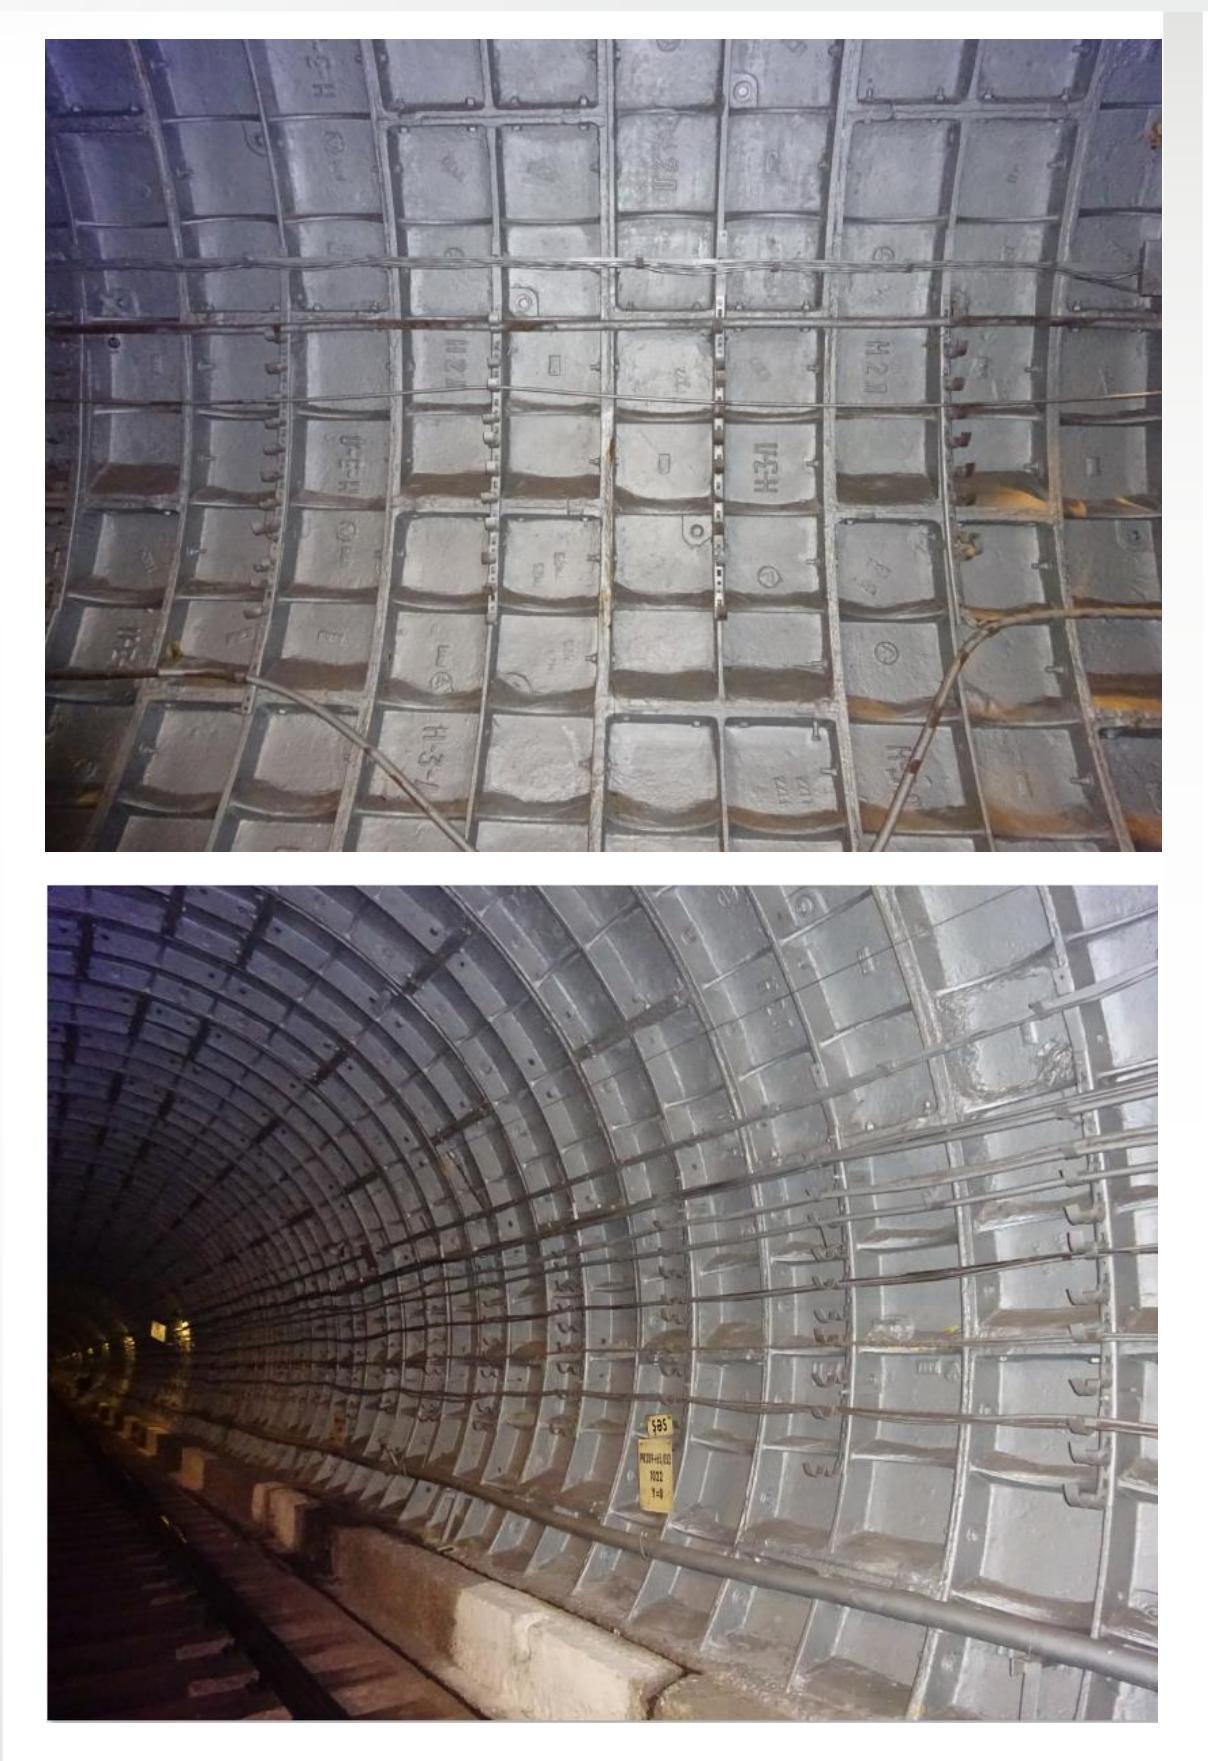
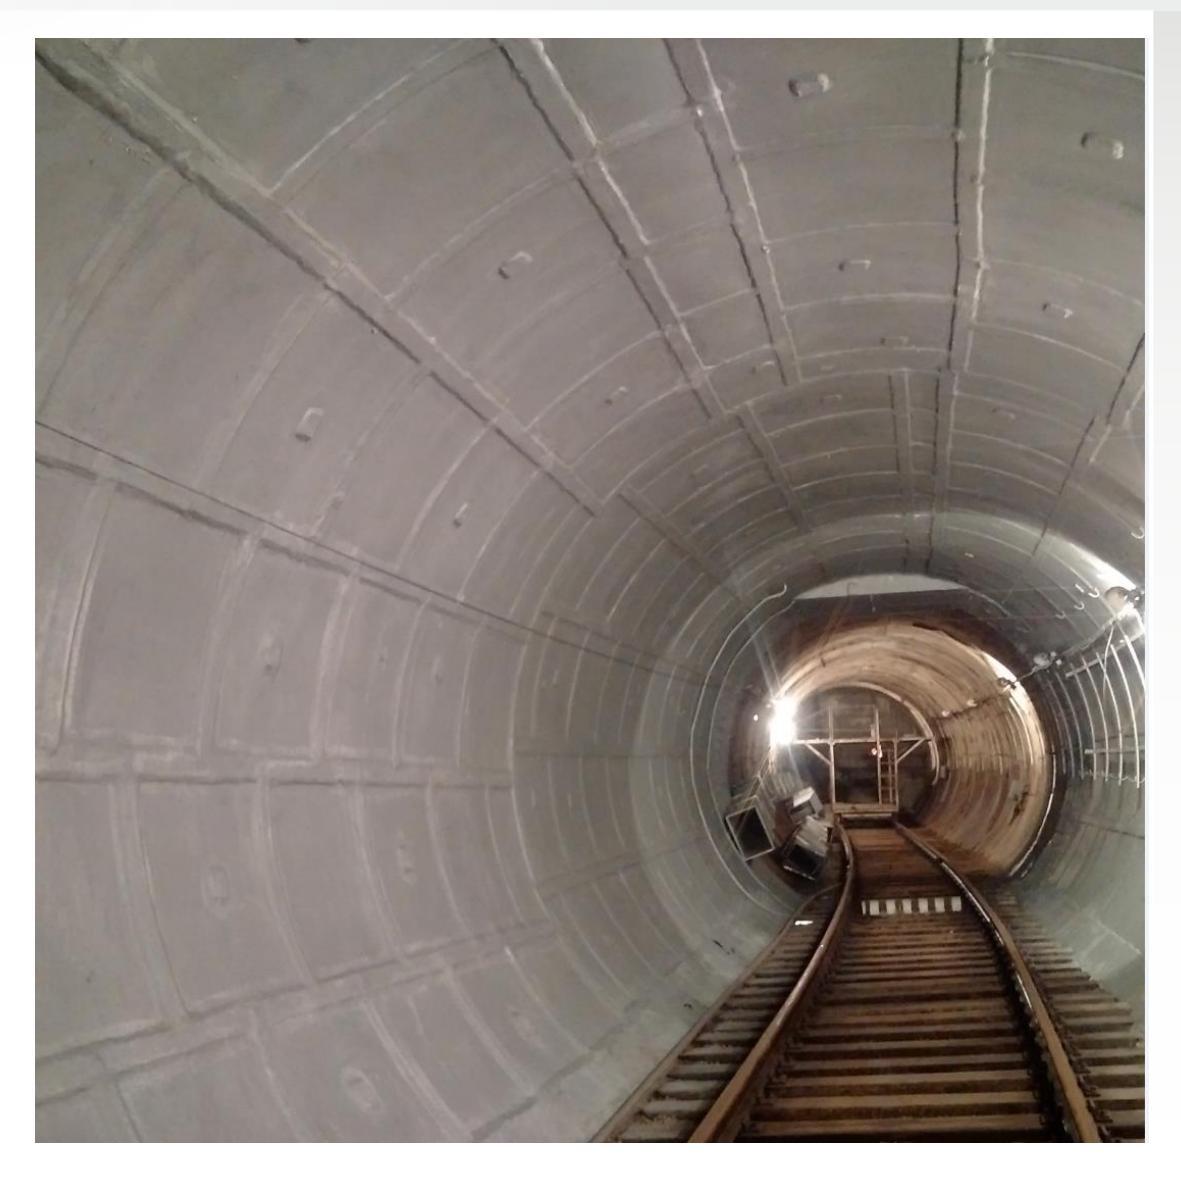
On next page you find some images after completion of different Metro sections.
